Preliminary Geotechnical Evaluation Report

Hilltop Horizon Specific Plan
Richmond, California

**RE: Preliminary Geotechnical Evaluation Report
Richmond Hilltop Specific Plan
Richmond, California**

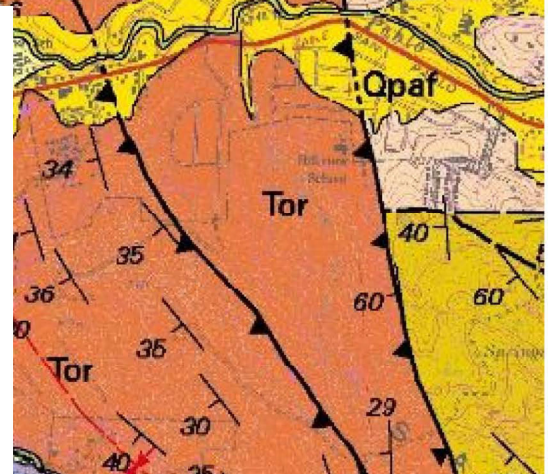
Qpaf	Alluvial fan and fluvial deposits (Pleistocene)
Qpaf1	Alluvial terrace deposits (Pleistocene)
Tor	Orinda Formation (late Miocene)
Tcgl	Conglomerate, sandstone, and siltstone (Pliocene and Miocene)
Tcglit	Rhyolite tuff and tuff breccia

The Plan Area is located on the northern slopes of the east Richmond hills, which trend northwest parallel to the Hayward Fault, toward San Pablo Bay. The Regional Geologic Map on Plate 4 (Graymer, 2000) illustrates the bedrock geology of the area. The Plan Area is mainly underlain by Orinda Formation rocks, which consist of non-marine sedimentary deposits of the late Miocene age. The Orinda Formation (map symbol Tor) is the predominant bedrock unit in the east Richmond hills and overlays the basement rocks of the Franciscan Complex in this area. The Orinda Formation is described by Graymer as follows:

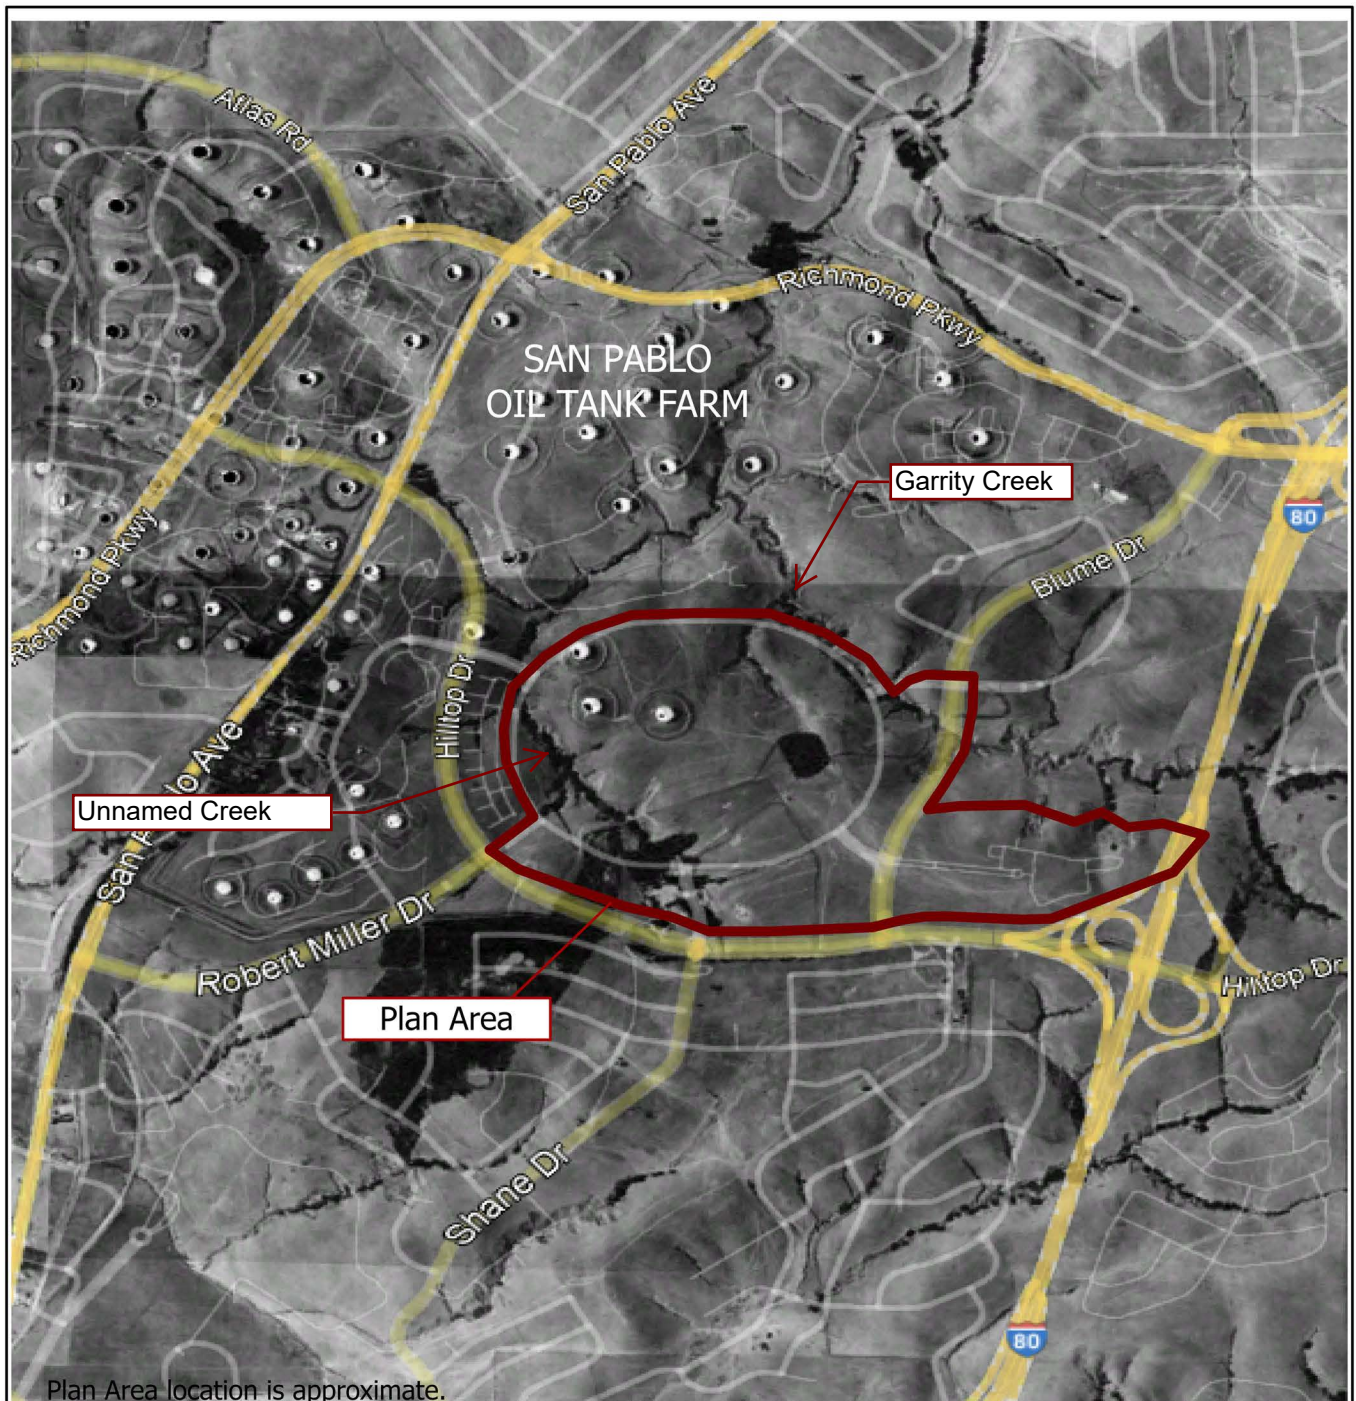
Plate 9

Plan Area location is approximate.

Photo Source: University of Santa Barbara Library, FrameFinder , Imagery Report: Flight C-5750

The regional liquefaction susceptibility map (Plate 7) shows the Plan Area as located within an area of “Very Low” liquefaction susceptibility (Knudsen et al., 2000 and Witter et al., 2006). A 1999 USGS landslides map (Plate 8) shows areas of “Mostly Landslides” on the east, northwest, and west sides of the Plan Area. Several landslides are visible in these areas on the pre-development 1939 historical aerial photograph presented on Plate 9.

Old landslide deposits are generally considered unsuitable for support of structures or structural fill and are subject to downslope movements such as creeping and sliding. The 1939 and 1965 historical aerial photographs (Plates 9 and 10) show evidence of landslides on the east, northwest, and west of the Plan Area prior to development of the Hilltop Mall. Based on the grading associated with the Hilltop Mall and surrounding development, some of these areas were likely covered with Artificial Fill to create the present-day relatively flat topography. The method and engineering of the fill placement is unknown. Based on the foregoing, we consider the potential hazard for encountering old landslide deposits to be high in the east, northwest, and west of the Plan Area, near the historical drainage channels. We consider there to be low potential for encountering landslide deposits in other areas of the Plan Area.

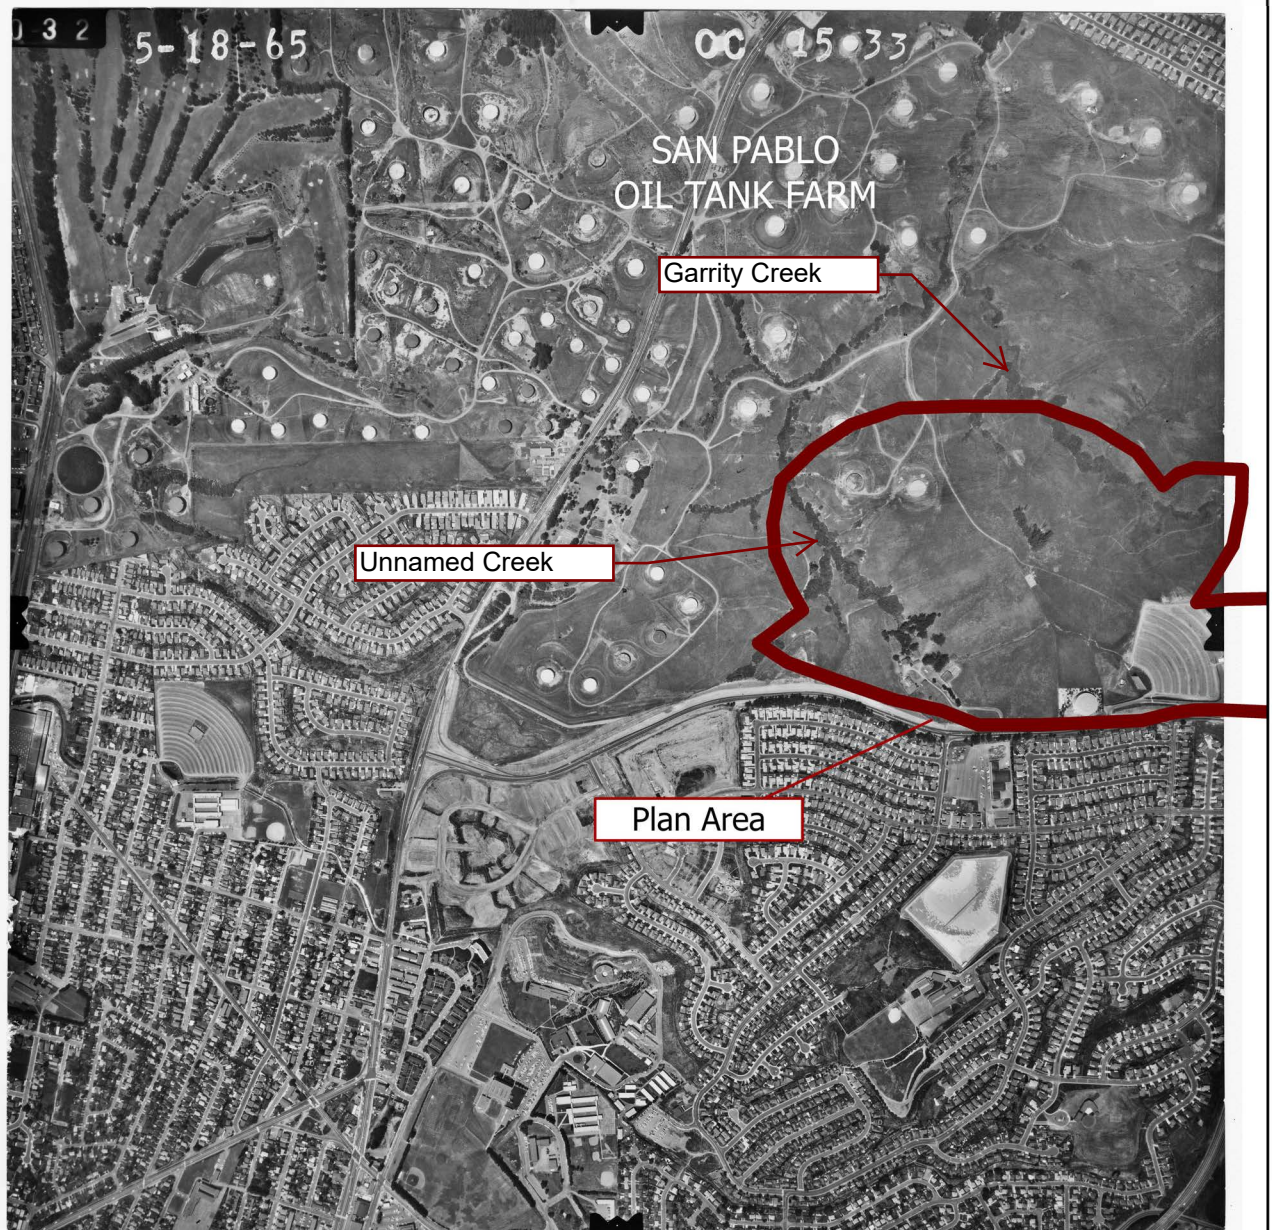
Plate 10

Plan Area location is approximate.

Photo Source: University of Santa Barbara Library, FrameFinder , Imagery Report: Flight CAS-65-130
